## System Report

Following reports of some wavelength problems with the films from this machine, an RGA ( *residual gas analysis* ) scan was performed in order to rule out any machine issues such as water and air leaks.

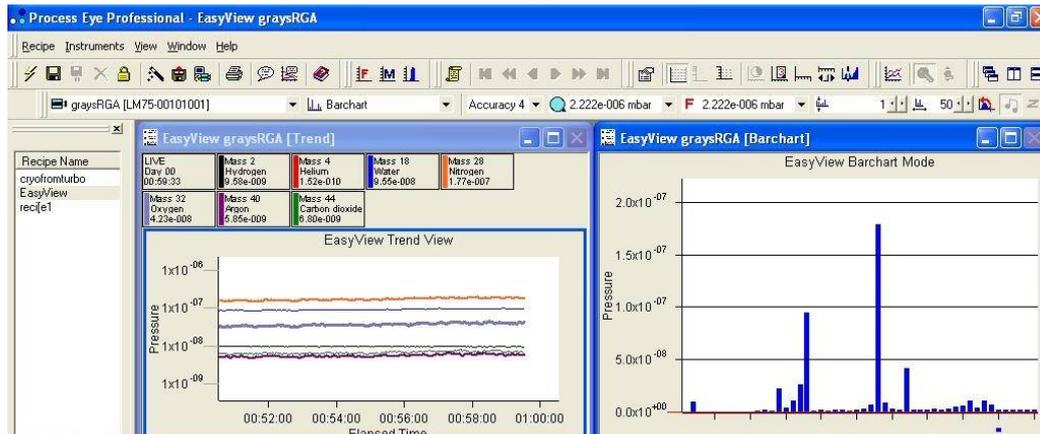
The first image is a snapshot of the system taken after an hour of pumping, system empty. The peaks at mass 28 (nitrogen) and mass 32 (oxygen) indicate that there is an air leak present.

During test of the dynamic seals, out technician noticed that the 28/32 peaks changed with the operation of the substrate rotation, so the system was vented and substrate carrier rotary drive seals were changed.

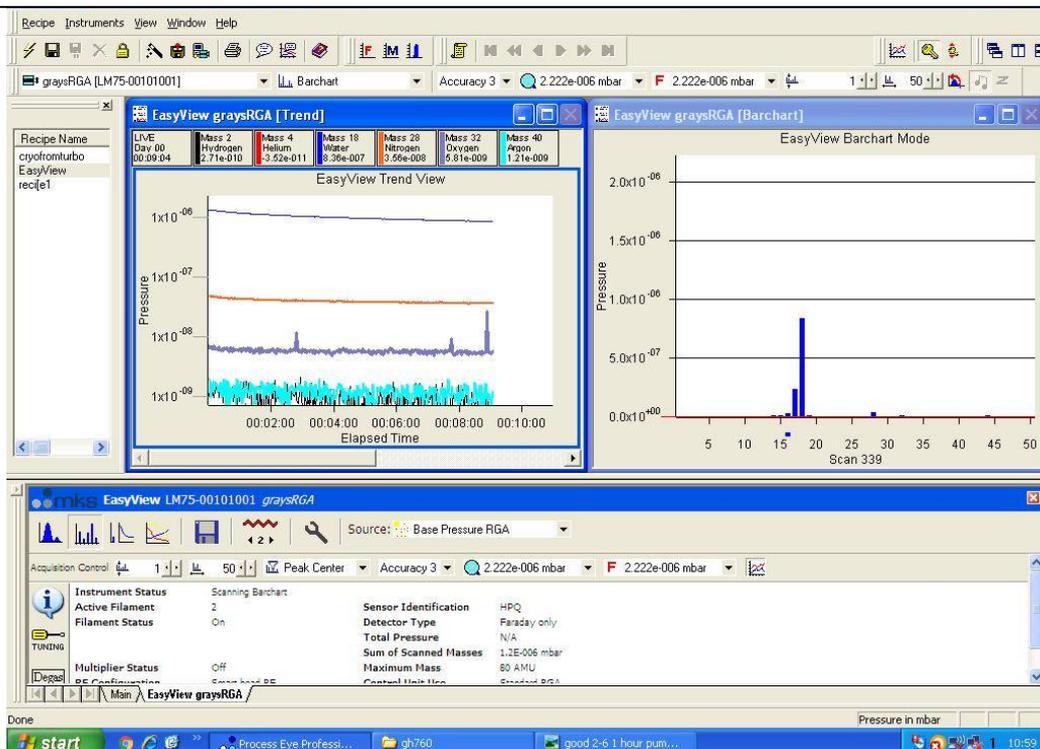
The second image, following the repair and a short pump down period, the scan shows a normal trace. Minimal peaks at 28/32, and the peak at mass 18 shows the normal background water vapour present in all systems.

The system performed a successful test run, and shortly afterwards was returned to normal production
